## **IMPACT OF TAILINGS DUMPS ON SUBSURFACE WATER FLOW: INSIGHTS FROM SINO METALS**

**Abstract:** The hydrological characteristics of ground water around the Sino Metals Leach tailings dumps area were studied by determining the water table elevations in boreholes, the gradient of the water table, flow directions, the water flow parameters such as – coefficient of permeability ‘K’, Flows speed. This was with a view to establish extent of pollution of ground water and dispersion of pollutants at Sino Metals Leach tailings dumps facility

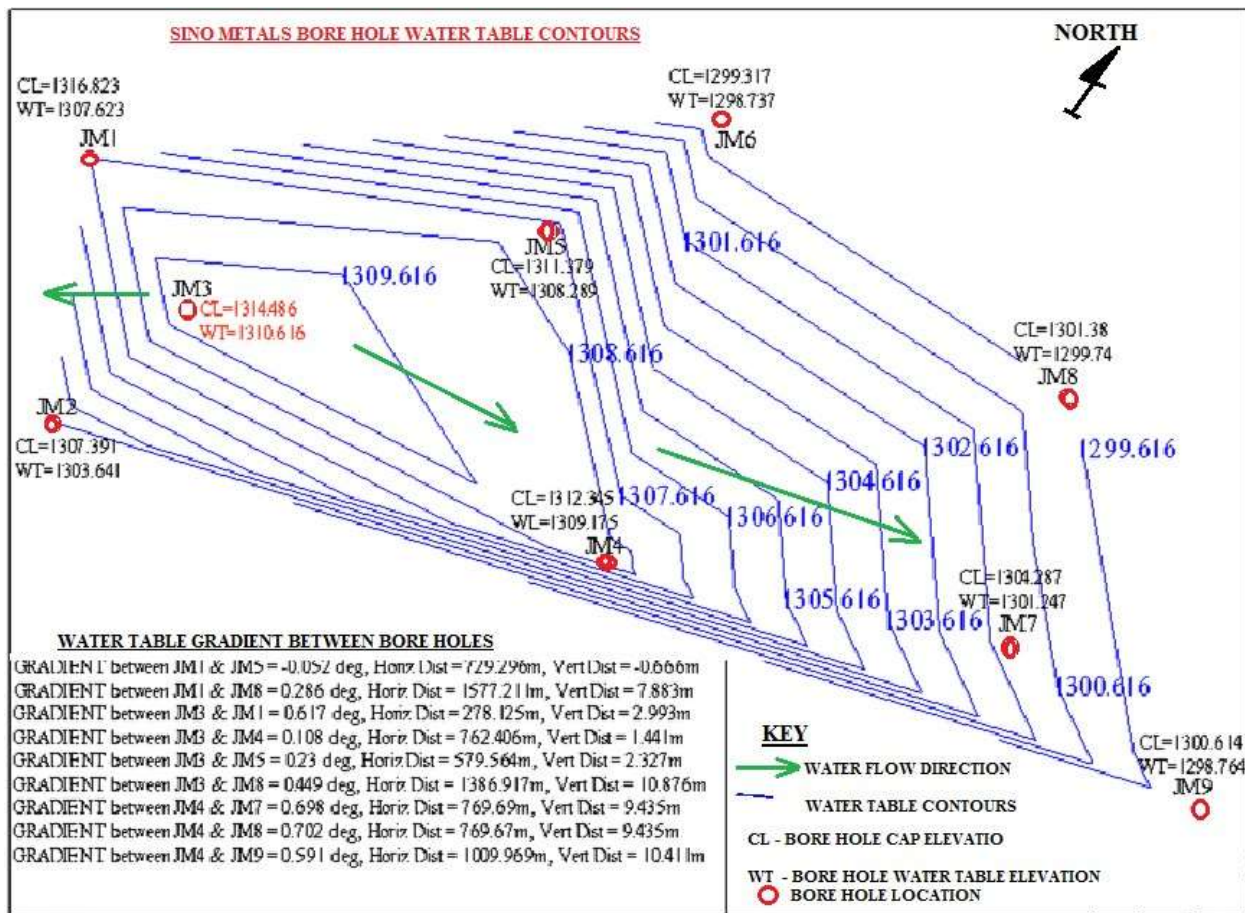
**Figure 4: Water table elevation as generated by Surpac software**

From the contour plots, it is clear that the water table high is at borehole number MJ3 (1310.616m elevation). The general trend or gradient is towards borehole number MJ 7, MJ8 and MJ9. This trend seems to represent the natural trend. There is a possible South West trending gradient (toward MJ2 and MJ1). This western gradient is likely to be influenced by mining activities (ID 15 and West Ore body). However, the study indicates that major flow direction is West-East in line with major trend in the faulting system as defined by the Lufirian arc (a major structural trend on the Copperbelt and North Western Provinces). This trend was also noted by NFC – Africa Mining on the water monitoring project for the South East orebody (February report by Applied Science and Technology Associates, March, 2013).

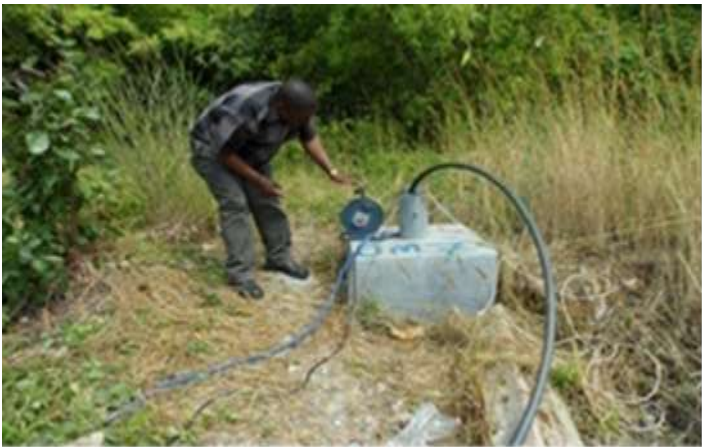
**Figure5: Pumping test at borehole MJ7**

To achieve this objective, borehole recovery method was adopted to get the necessary parameter  $t_1, t_2$  and  $h_1, h_2$ . The table below gives the values calculated in the 5 boreholes selected (security issues in Chambishi metals did not allow pump test). Borehole MJ7 gave erroneous value as water seems to have been gushing from a crack or fissure. The table below gives 'K' values for the other borehole tests done.

\* Water gashing through a cavity intersected by the bore hole

All the holes except JM 7 showed similarities in the water flow. The gashing of water in JM7 indicated the presence of a cavity. Cavities of this nature occur in solid rockmass. The flow velocity of water is higher in the cavities. This could be the source of concern if some pollutants can get to the bedrock. The transmission of pollutants could be wide spread in a short time. However as it stands, the low permeability of the lateritic soils below the tailings dumps helps in slowing down the rate of pollution and in most cases the pollutants are trapped in the soil where they undergo degeneration over a period of time.

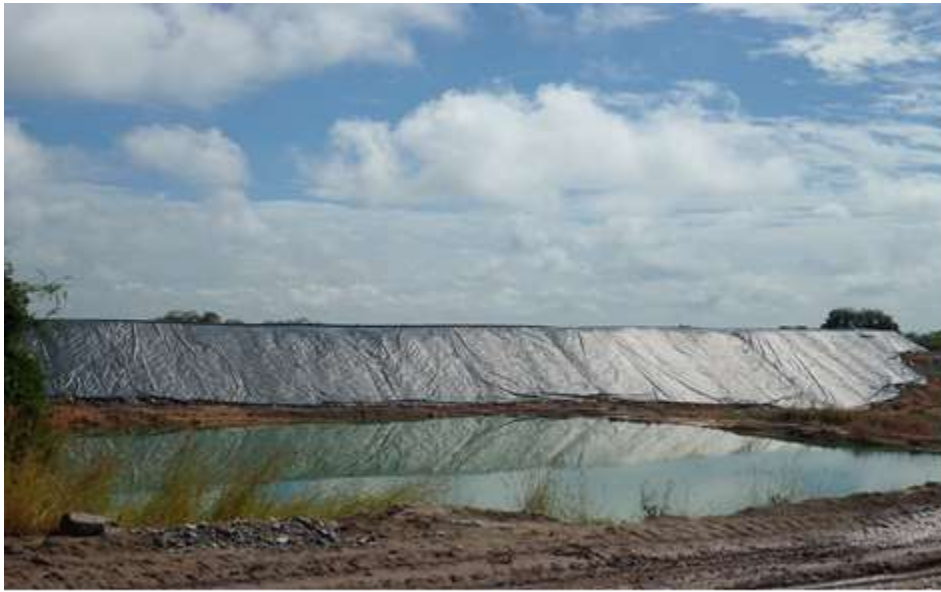
**Figure8: Recommended HDPE lining for new tailings dumps (TD7)**

- Covering the base of a new tailings dump with HDPE membrane must be done to prevent seepage of acidic waters to the underlying soil or ground water.
- Liming of the tailings discharged from the leach plant should be done to neutralize the tailings before disposal.
